Intel[®] Core[™] i7 Processor Family for LGA2011-v3 Socket

Specification Update

Supporting Desktop Intel[®] Core[™] i7-6950X Extreme Edition Processor for the LGA2011-v3 Socket

Supporting Desktop Intel[®] Core[™] i7-6900K, i7-6850K, and i7-6800K processors for the LGA2011-v3 Socket

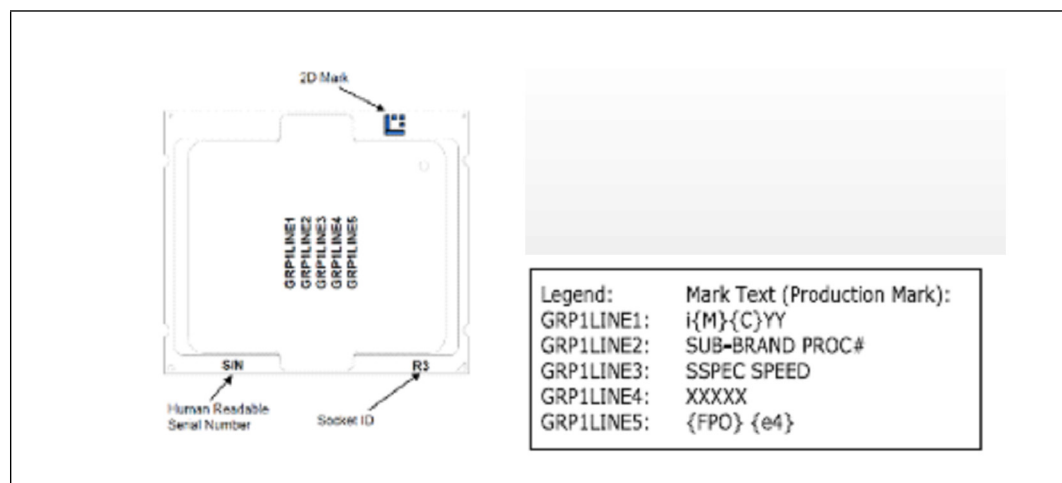
Figure 1. Processor Top-side Markings (Example)

The processor stepping can be identified by the following component markings. Refer to the Dear Customer Letter (DCL) for additional details and conditions of test support.
